Helpful Home Inspection Report

123 Row House, Anytown, USA

Inspection Date:
Tuesday, January 5, 2010

Report Number:
S01051013

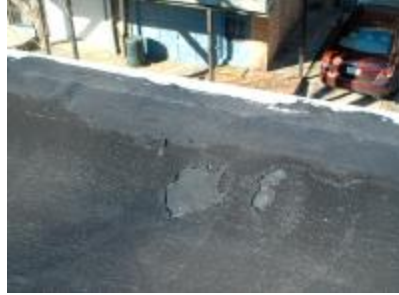
- Material Defect:** The roof coverings are in various states of disrepair. Some asphalt shingles are missing at the shed roof at front. Others are torn. Replace this roof covering now. Replace the old worn porch roof covering now. The main roof is not so old, but exhibits flaws typical of an older roof due to lack of maintenance. It may be possible to extend the life of this roof covering by repairing the damaged areas, resealing the edges and penetrations and providing a reflective coating. Consult a roofing contractor about the relative cost-effectiveness of repair versus replacement at the main roof.

Main roof...damaged areas...

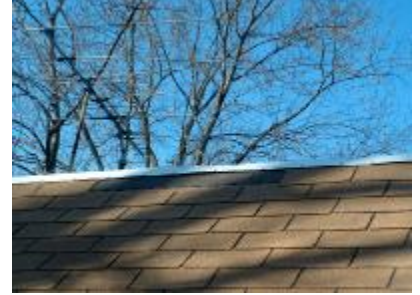
Shingles are missing...

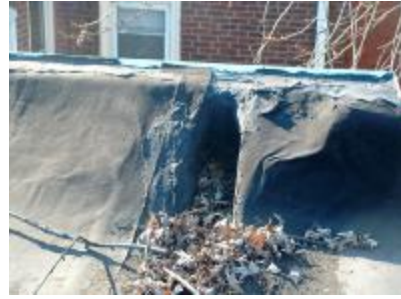
Congested roof drain...

- Repair:** Clear the congested roof drain at the main roof and maintain all drains free of debris to reduce roof damage and risk of leaks and to avoid spilling roof runoff around the building – a potential source of water entry or water damage.

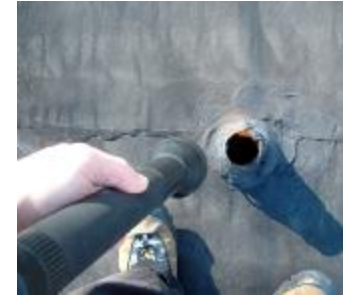
Pipe...open into the attic...

- Repair:** There is a pipe at the main rooftop that is open into the attic. To eliminate this point of entry for water and vermin, replace the pipe with a proper rooftop attic vent.

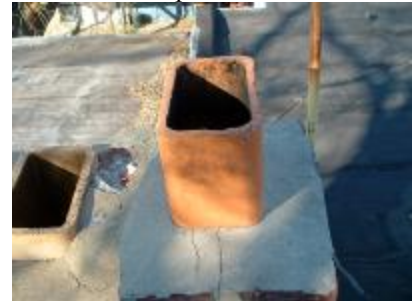
Seal cracks in the cement wash...
Install a rain cap and vermin screen...

- See page 106 "Check Gutters and Downspouts" in *How To Operate Your Home*.
- Repair:** Seal cracks in the cement wash at the top of the chimney to prevent water penetration and further damage.

- **Improve:** Install a rain cap and vermin screen atop the chimney flue to help keep rain and vermin out.
- *See page 213 "Inspecting a Masonry Chimney" in How To Operate Your Home.*
- **Safety Issue:** A single chimney flue serves a wood burning fireplace and the gas burning boiler and water heater. This is a potentially hazardous arrangement that is not permitted in modern construction. I am aware of at least two concerns with this arrangement. 1) In general, different fuels will require differently sized liners to help ensure the safe exhaust of flue gases. 2) Wood fires create creosote, which is highly combustible. Adding other openings to the chimney could allow a fire to spread outside of the chimney. Consult a fireplace and chimney expert.

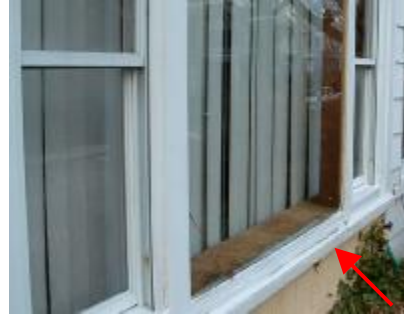
Rotted...frames, trim and sills...

- **Repair:** Make painting, caulking and glazing (putty) improvements as needed at windows and window frames. Repair or replace rotted window frames, trim and sills, and replace broken glass, including at the fixed pane at the front porch. The detail at the exterior of the dining room window is poor. Repair or replace the sill and frame as needed to reduce the risk of water entry and damage to the building.

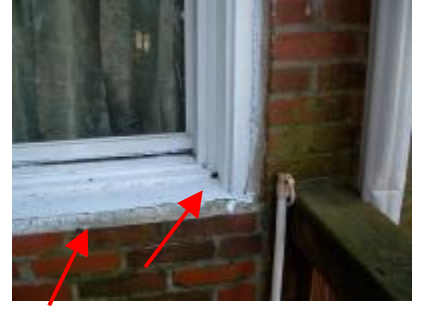
Reduce the risk of water entry...

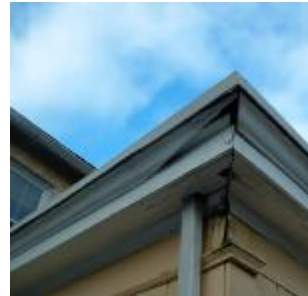
- **Repair:** Clean, prime and paint exterior wood surfaces. Repair or replace any rotted wood that may be found while preparing surfaces for paint. There is visible rot at the front porch, including at the eaves and siding. There

Rot at eaves...

is a risk of additional hidden damage in these areas.

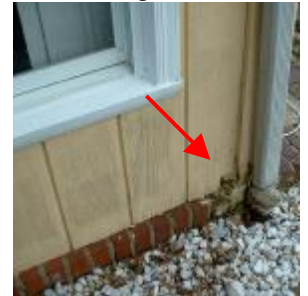
Rot at siding...

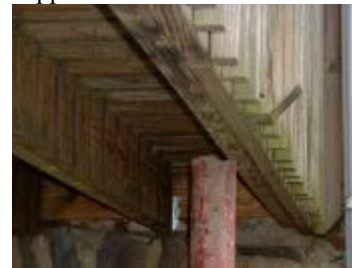
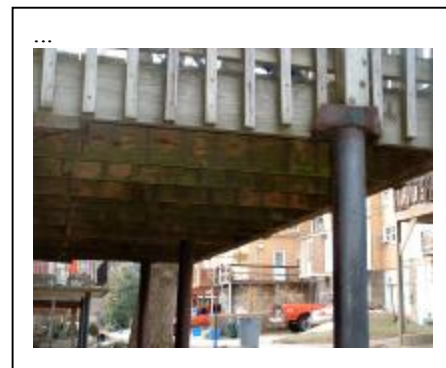
Posts...do not provide proper support...

- **Repair:** Repair or replace the deck as needed to conform to accepted construction standards. Consult a design professional and/or visit us on-line at www.helpfulhomeinspectors.com/links.htm for links to guidelines on building a safe and sound deck. Nails alone do not provide a sufficient connection between the deck and the house. Posts placed beneath individual joists do not provide proper support for the deck. The posts should support a beam or beams that, in turn, support the deck.
