Helpful Home Inspection Report

123 Any Street, Hometown, USA

Inspection Date:
Monday, January 8, 2007

Report Number:
S01080709

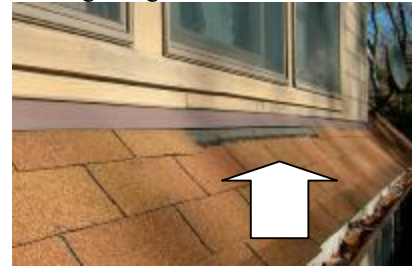
- **Repair:** Minor repairs to the roofing are needed to prevent leaking. Repair or replace damaged or missing shingles, including at the eaves at front and rear. Replace loose nails. Examine all roof penetrations and seal as necessary.

Repair or replace damaged or missing shingles...

- **Repair:** Minor repairs to the roofing are needed to prevent leaking. Repair or replace damaged or missing shingles, including at the eaves at front and rear. Replace loose nails. Examine all roof penetrations and seal as necessary.

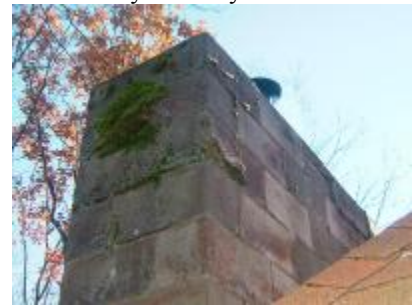
- **Repair:** Repair the damaged cap, spalling masonry and deteriorated mortar at the masonry chimney as needed to avoid further damage. Consult a chimney expert.

Repair the damaged cap, spalling masonry and deteriorated mortar at the masonry chimney...

- **Repair:** Repair the damaged cap, spalling masonry and deteriorated mortar at the masonry chimney as needed to avoid further damage. Consult a chimney expert.
